UNDERSTANDING YOUR CRA

(CERTIFIED REPAIR ANALYSIS)

A Note To Homeowners: It takes a MoistureFree Certified expert to inspect and repair your home, but you don't have to be an expert to understand most of the moisture problems that occur on your home. This guide is intended to help you understand the most common exterior moisture problems. Remember, you can always call the experts at MoistureFree Warranty to help you with any of your home's moisture problems. Our goal is the same as yours...a dry home!

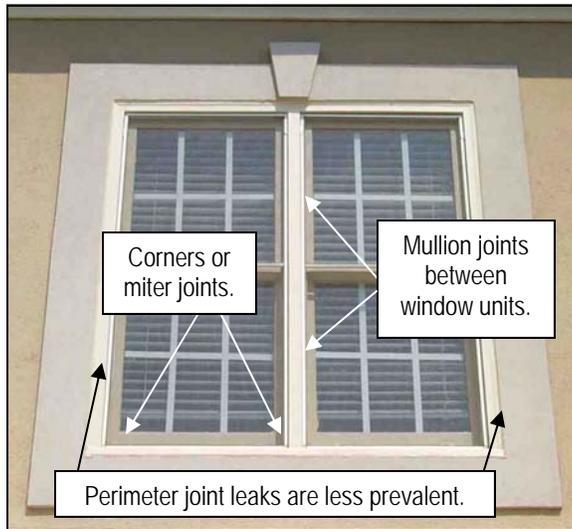
Typical Double-Hung Windows

Most leaks occur at the corners (miter joints) and the mullion (the divider between the windows). The perimeter only makes up about 10% of window leaks.

About 70% of all leaks in the cladding are caused by windows. These types of leaks happen on all homes, regardless of the type of cladding. Most of the leaks occur within the construction of the window itself. However, many people mistakenly assume that most leaks occur around the perimeter of the window where it meets the cladding. The following illustrations show the most common problems with windows.

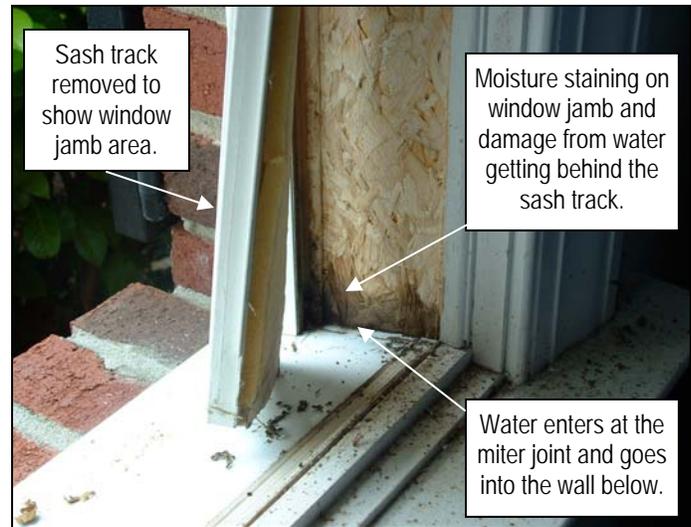
Behind The Sash Tracks of Double-Hung Windows

This is a photo of the miter joint behind the plastic sash track on a double hung window. Moisture that gets behind the sash track can drain directly into the wall cavity.

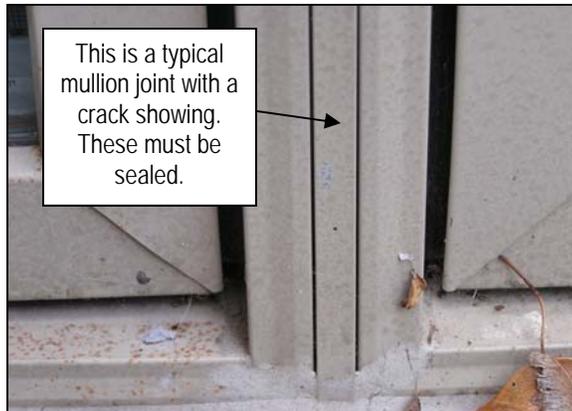
Seal The Mullion Joints

The mullion is the joint between sets of window units. Openings in the mullion joint can allow moisture to enter the wall.

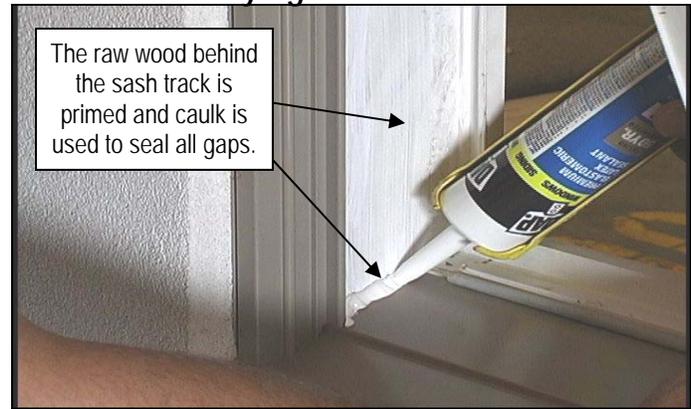
Modifying The Miter Joint

This is a photo of a double hung window with the sash track removed. When properly primed and sealed, the miter joints of windows can be successfully repaired and will stop most leaks.

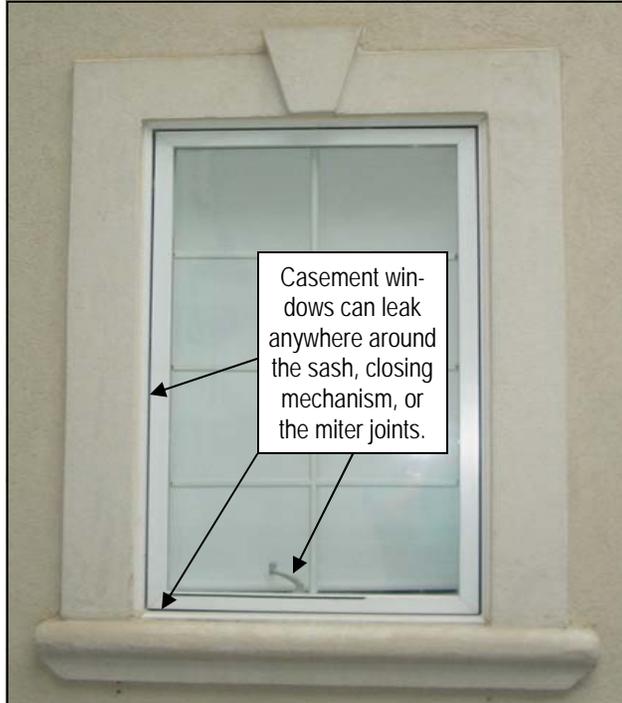
Typical Casement (crank out) Window

About 15% to 22% of casement style windows experience some moisture problems. Most of these leaks occur within the construction of the window itself and not at the perimeter. Caulking is typically not a reliable method of repairing these leaks, and many casement windows require pan flashings.

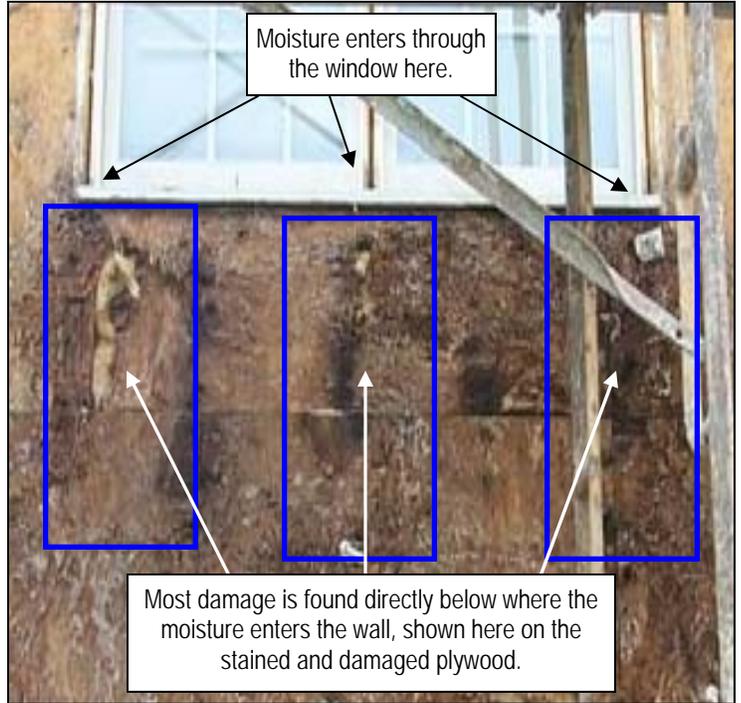
Typical Damage Pattern

This degree of damage is not typical under casement windows, but it illustrates the typical pattern of damage under windows in severe cases. The damage is concentrated under the corners and the mullion joint between the window units (shown in the boxes).

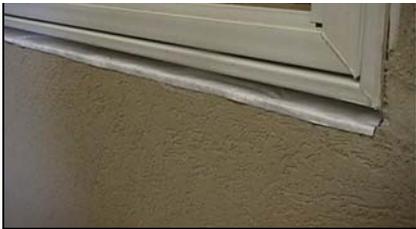
Step 1: Creation of an opening of 1/2" under the length of window.

Some windows require drain pans be installed to catch leaking water and direct it to the exterior. MoistureFree Warranty recommends the DamSill™ window pan system because of its reliability and ease of installation. DamSill can be installed without removing the window unit.

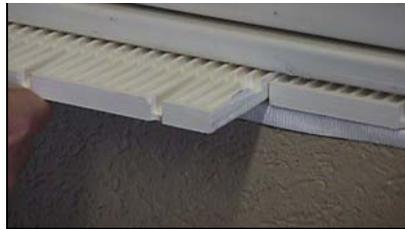
Step 2: DamSill™ is installed under the entire length of the window.

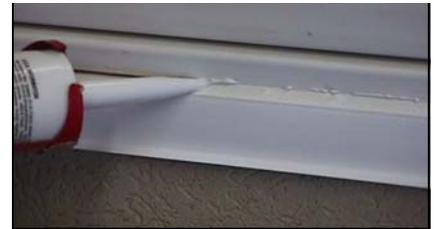
Step 3: Installation of finishing trim to hide the pan and protect the area.

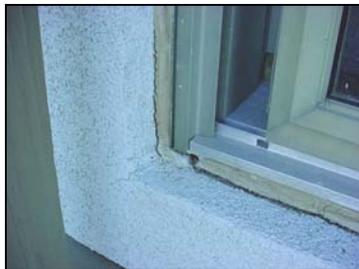
Failing Caulk: The correct type of caulk and proper installation of the caulk is required.

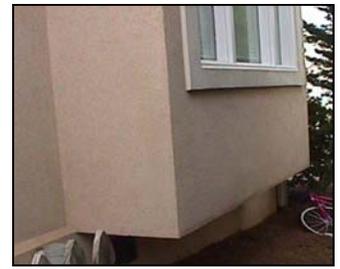
Bay and Cantilevered Windows: Areas below these windows may have significant damage.

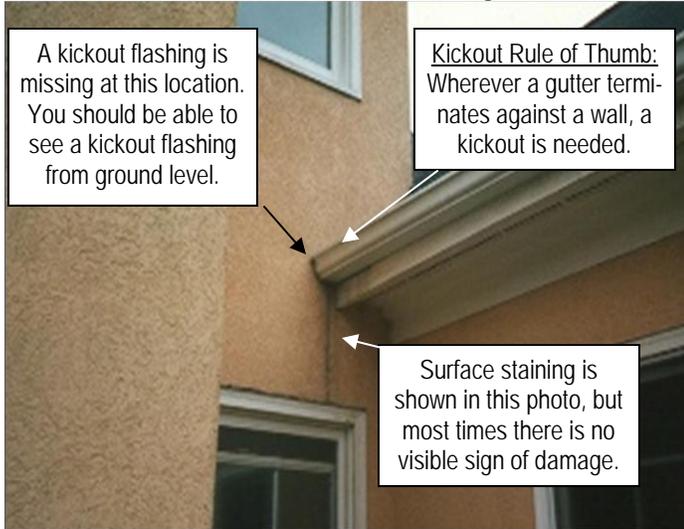
What Is A Kickout Flashing?

A kickout flashing is a flashing that directs water away from the home and is located where the roof edge terminates against a vertical wall. If the kickout flashing is missing or installed incorrectly, water from the roof can run directly into the wall cavity.

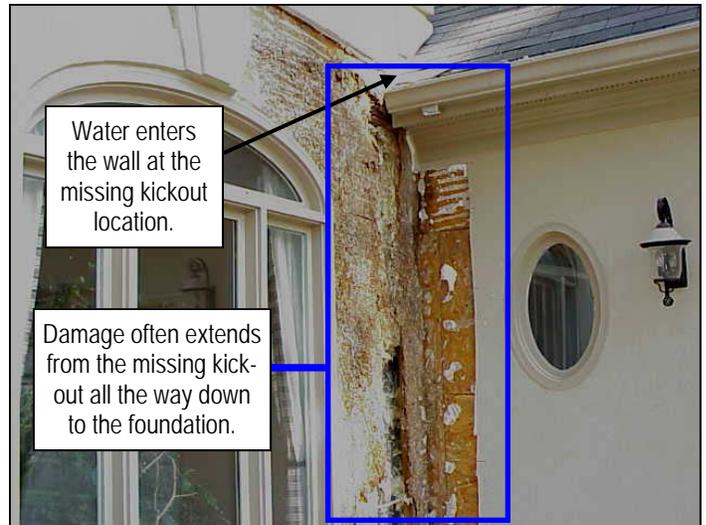
Typical Damage At Kickout Location

Because significant amounts of water can enter the wall at a missing or improper kickout location, severe damage is possible. Most homes have an average of 4 kickout locations, at least one of which is usually leaking.

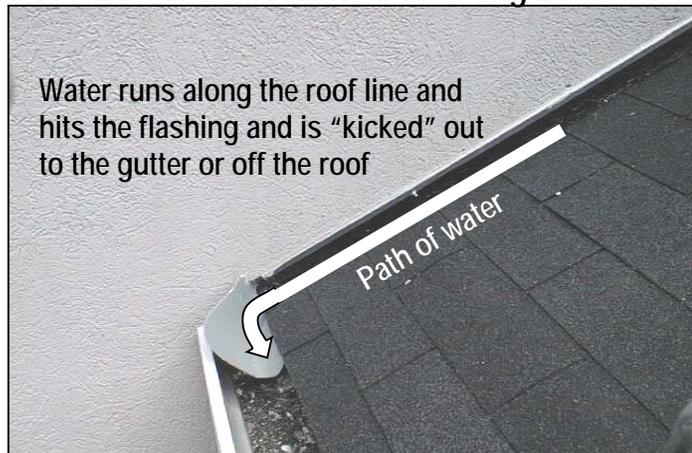
What Does A Kickout Flashing Do?

Water that runs along the edge of the roof is kept away from the wall by step flashing. However at the edge of the roof, the step flashing ends. If the stucco or EIFS is installed over the top of the step flashing, the water will run behind the stucco and into the wall. The kickout flashing catches the water at the end of the step flashing and directs it away from the wall.

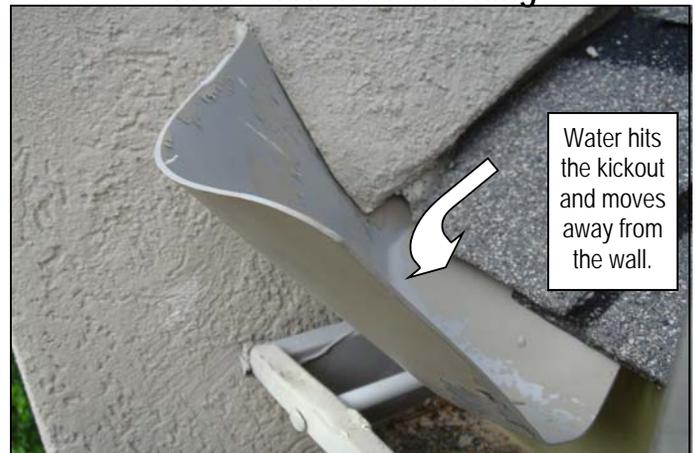
A Good Kickout Flashing

A MoistureFree approved kickout flashing is a pre-engineered, weather tolerant plastic flashing that fits behind the last piece of step flashing. The brand name is Raintec® and is easily available to all repair contractors. Make sure that your contractor uses only a MoistureFree approved kickout flashing on your home as others are oftentimes unreliable.

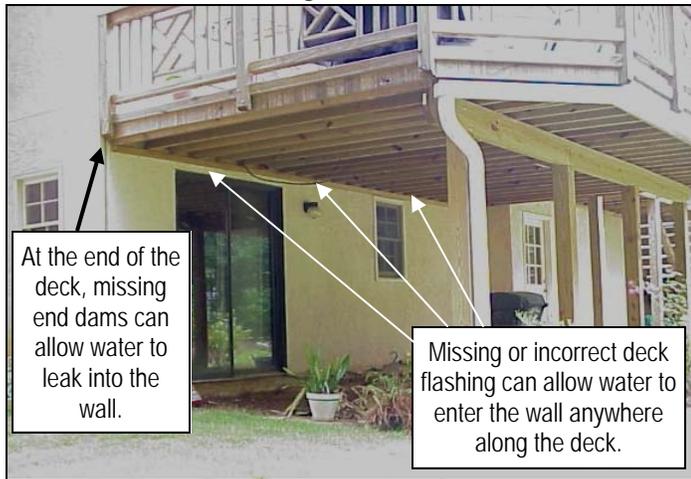
Problem #3—Attached Decks Deck Flashings and End Dams

At the end of the deck, missing end dams can allow water to leak into the wall.

Missing or incorrect deck flashing can allow water to enter the wall anywhere along the deck.

Most decks are attached directly to the framing of the home. The joint where the deck is attached must be flashed to protect the wall below. End dams are required to stop water at the edge of the flashing from flowing into the wall.

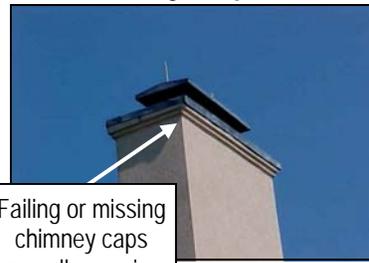
Problem #4—Chimneys Chimney Caps, Crickets and Flashings

Failing or missing chimney caps can allow moisture into the wall.

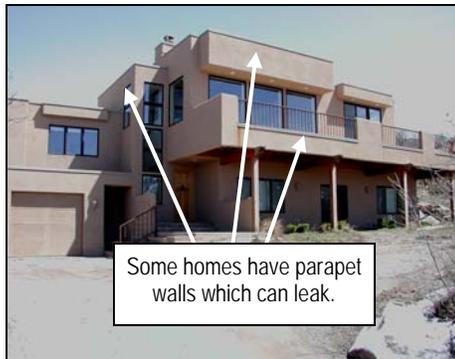
Problem #5 Parapet Caps—Tops of Walls

Some homes have parapet walls which can leak.

The top of parapet walls must have a proper cap to keep moisture from leaking into the wall.

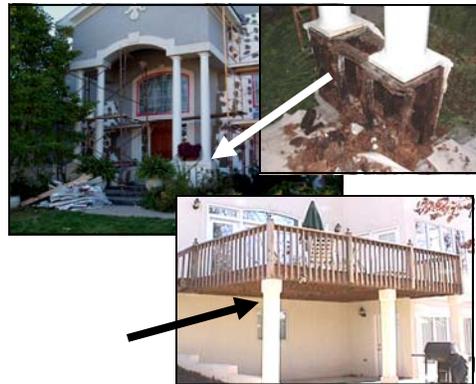
Problem #6 Support Columns On Decks & Other Areas

Support columns on decks and entry ways are often missing flashing and sealants.

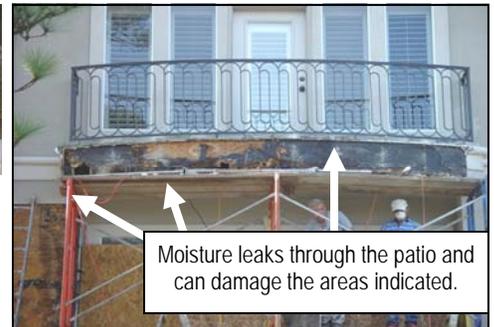
Problem #7 Raised Patios with Tile or Similar Treatment

Moisture leaks through the patio and can damage the areas indicated.

These types of patios are considered roofs, since they protect the area below. These must be modified to prevent water from damaging the area below and adjacent walls.

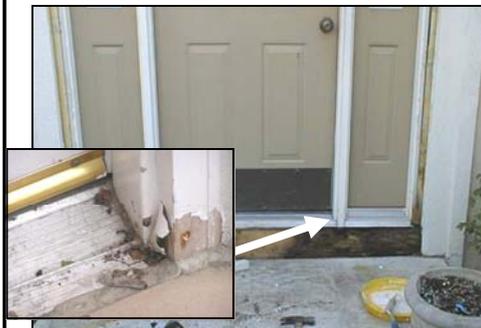
Problem #8 Door Leaks and Damage

Door leaks are similar to leaks at windows. The corners (miter joints) commonly have openings that leak. The threshold of the door may also be leaking. Modifications to the door must be made to stop these leaks. Framing below the door may require repair.

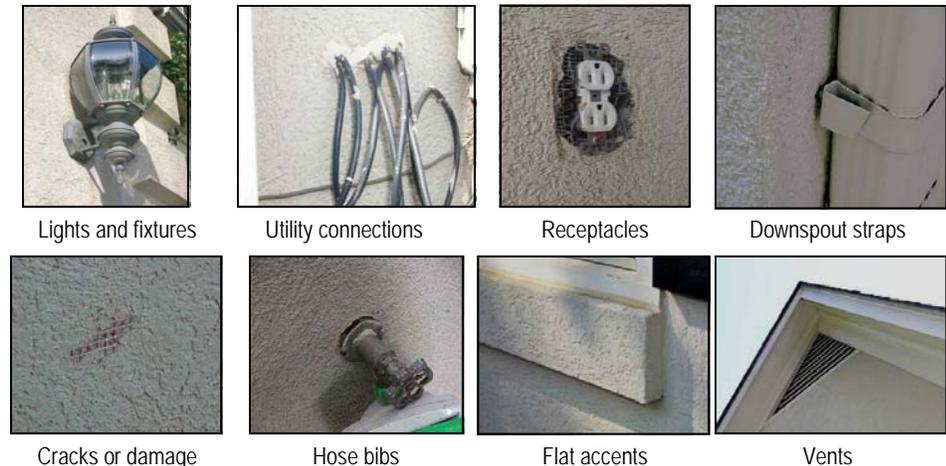
Problem #9 Other Locations That Must Be Sealed

Lights and fixtures

Utility connections

Cracks or damage
